4TH ANNUAL QUARRYING AND SMALL MINES SAFETY & HEALTH SEMINAR

Exploding Lead Acid Batteries

Presenter: Graeme Brown – Inspector of Electrical Engineering

Date: 21 March 2017

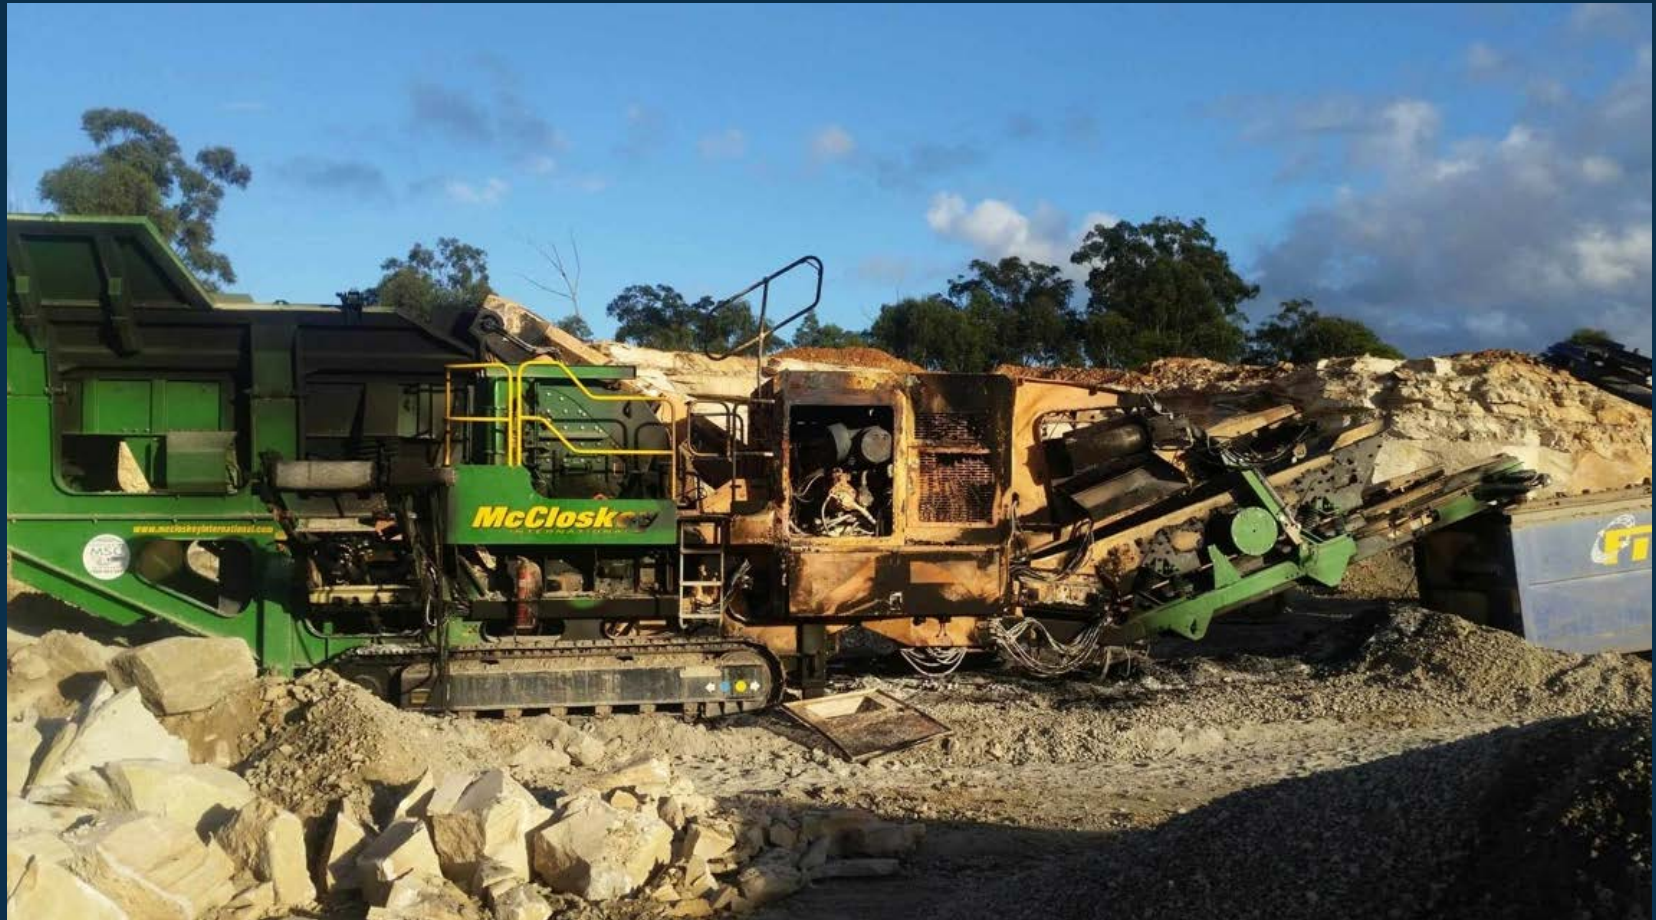
Photo from incident involving battery failure.

- Fire occurred over nite when equipment was not operating
- Police confirmed in their opinion causation of the fire was an electrical short from the wiring to the “Anderson Plug”
- Wiring insulation had worn through cabling to “Anderson Plug” causing a short circuit to earth
- Anderson Plug was used to jump start the machine
- Equipment loss - \$450,000
- Production loss ???????

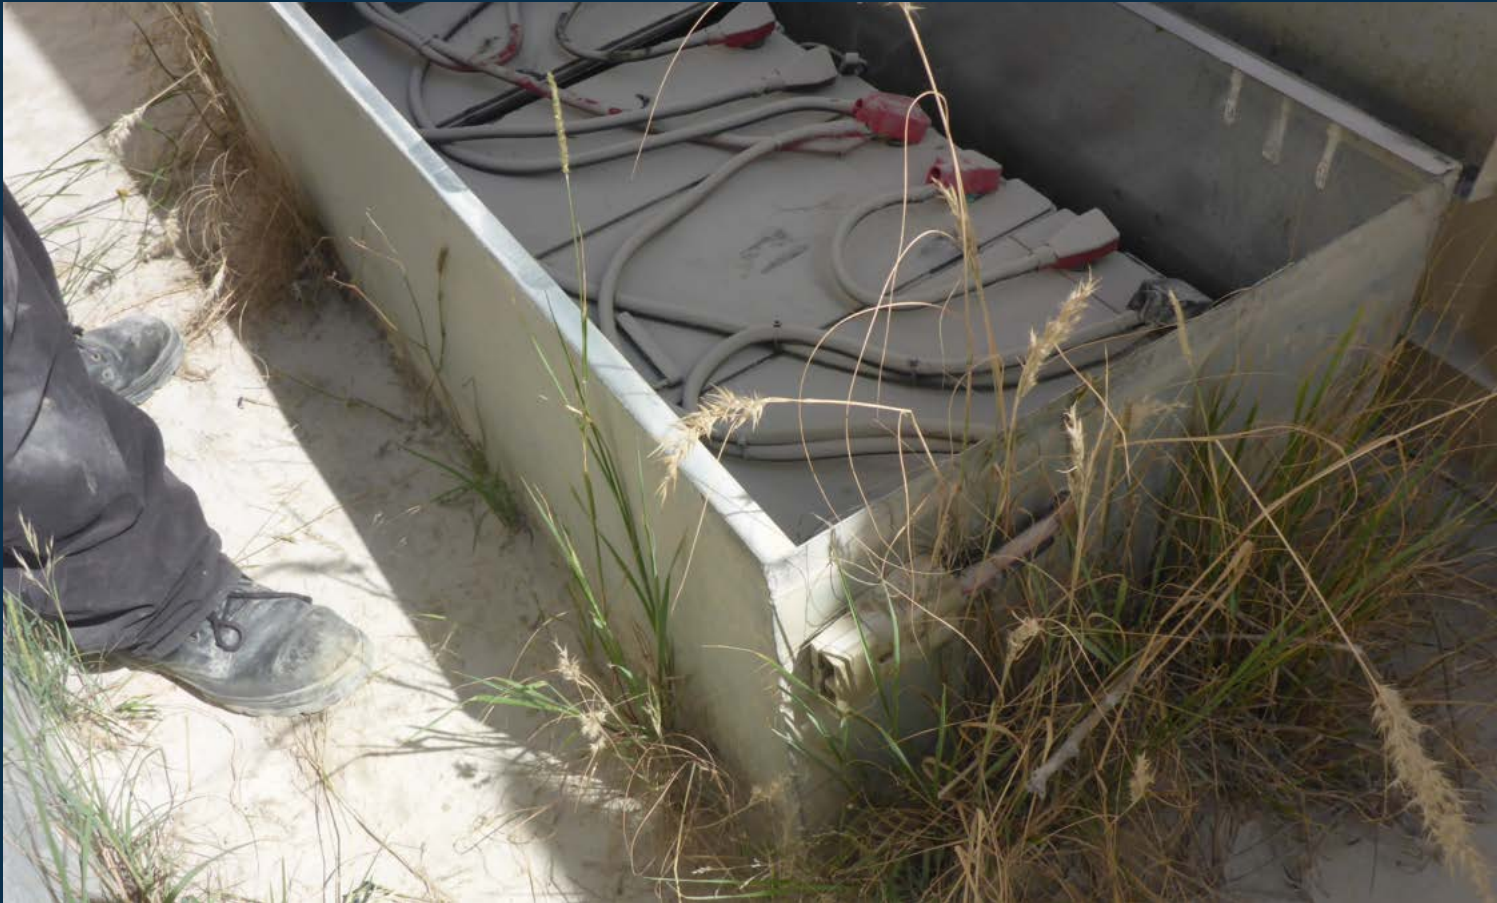
YOUR SITE – do your battery installations look like this?

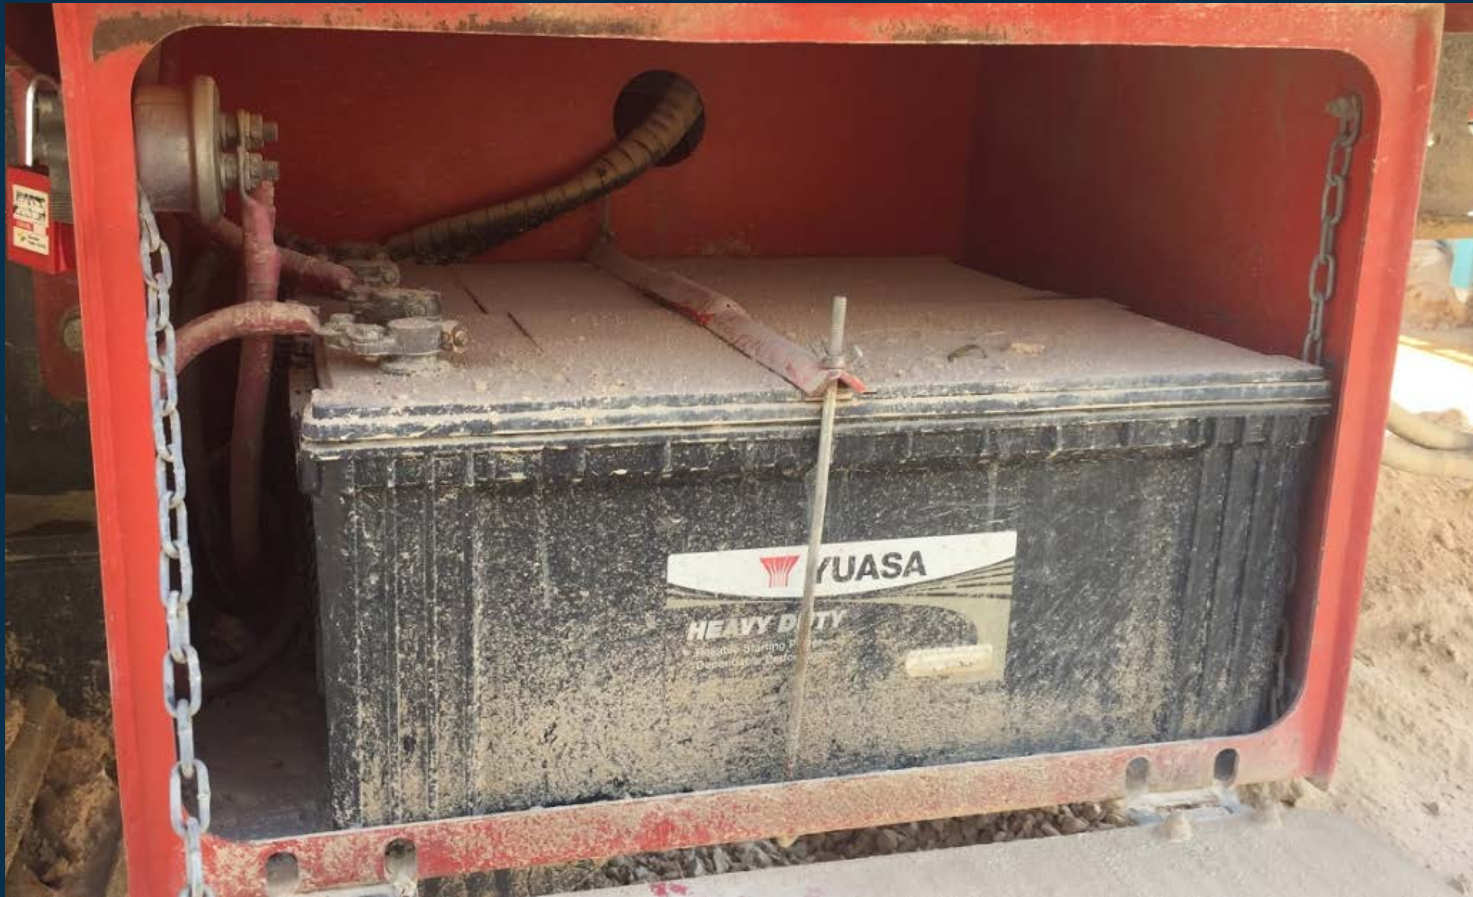
YOUR SITE – do your battery installations look like this?

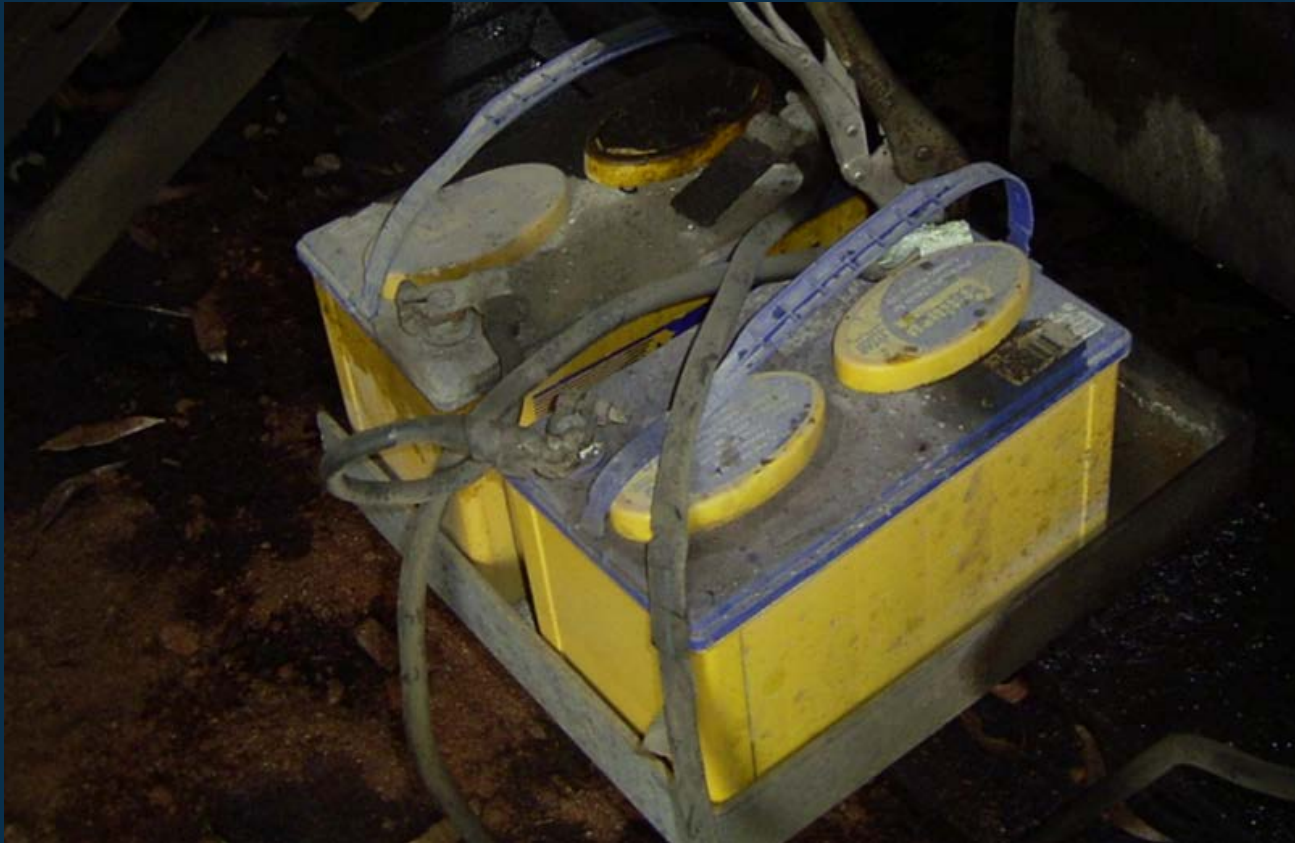
YOUR SITE – do your battery installations look like this?

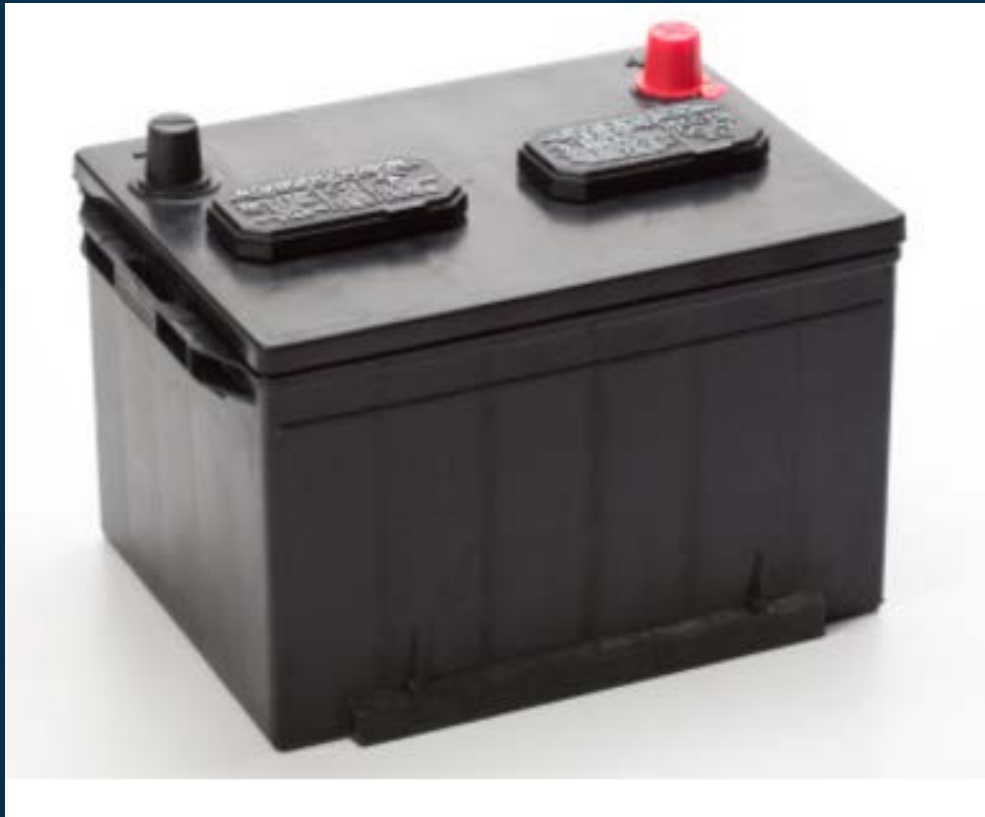
VENTED - Also termed “Maintainable”

ITEM	VENTED (MAINTAINABLE)	SEALED (MAINTENANCE FREE)
OPERATING POSITION	Flat Horizontal	Any
VENTILATION REQUIRED	YES Hydrogen emissions	YES Batteries are equipped with check valves that are engineered to open at between 2-3 PSI depending upon the specific brand. Hydrogen gas will be expelled if battery vents.

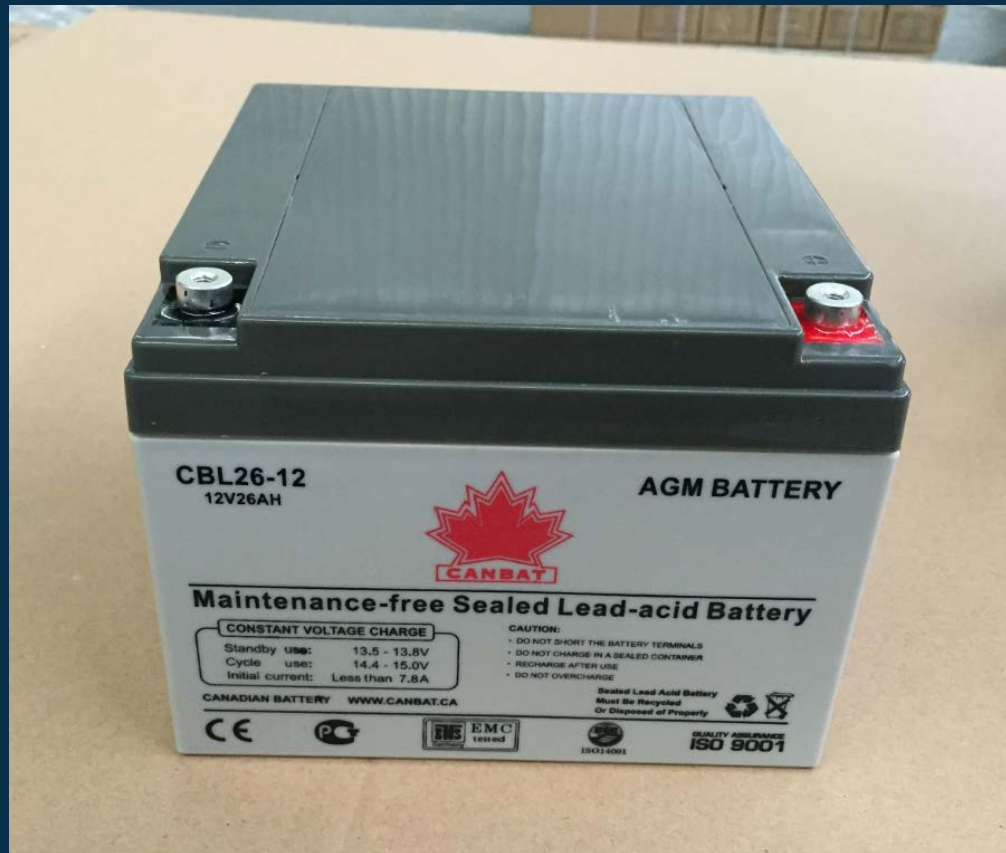
SEALED - Also termed “Maintenance Free”

- VLRA (Valve Regulated Lead Acid Battery) or
- AGM (Absorbed Glass Mat)
- Gel Cell
- Maintenance Free Battery.
